N-1744

January 1986

By M C Hironaka
and T J Holland

Blistering of Asphalt Pavement Overlay on Runway 14-32 at MCAS Beaufort, South Carolina

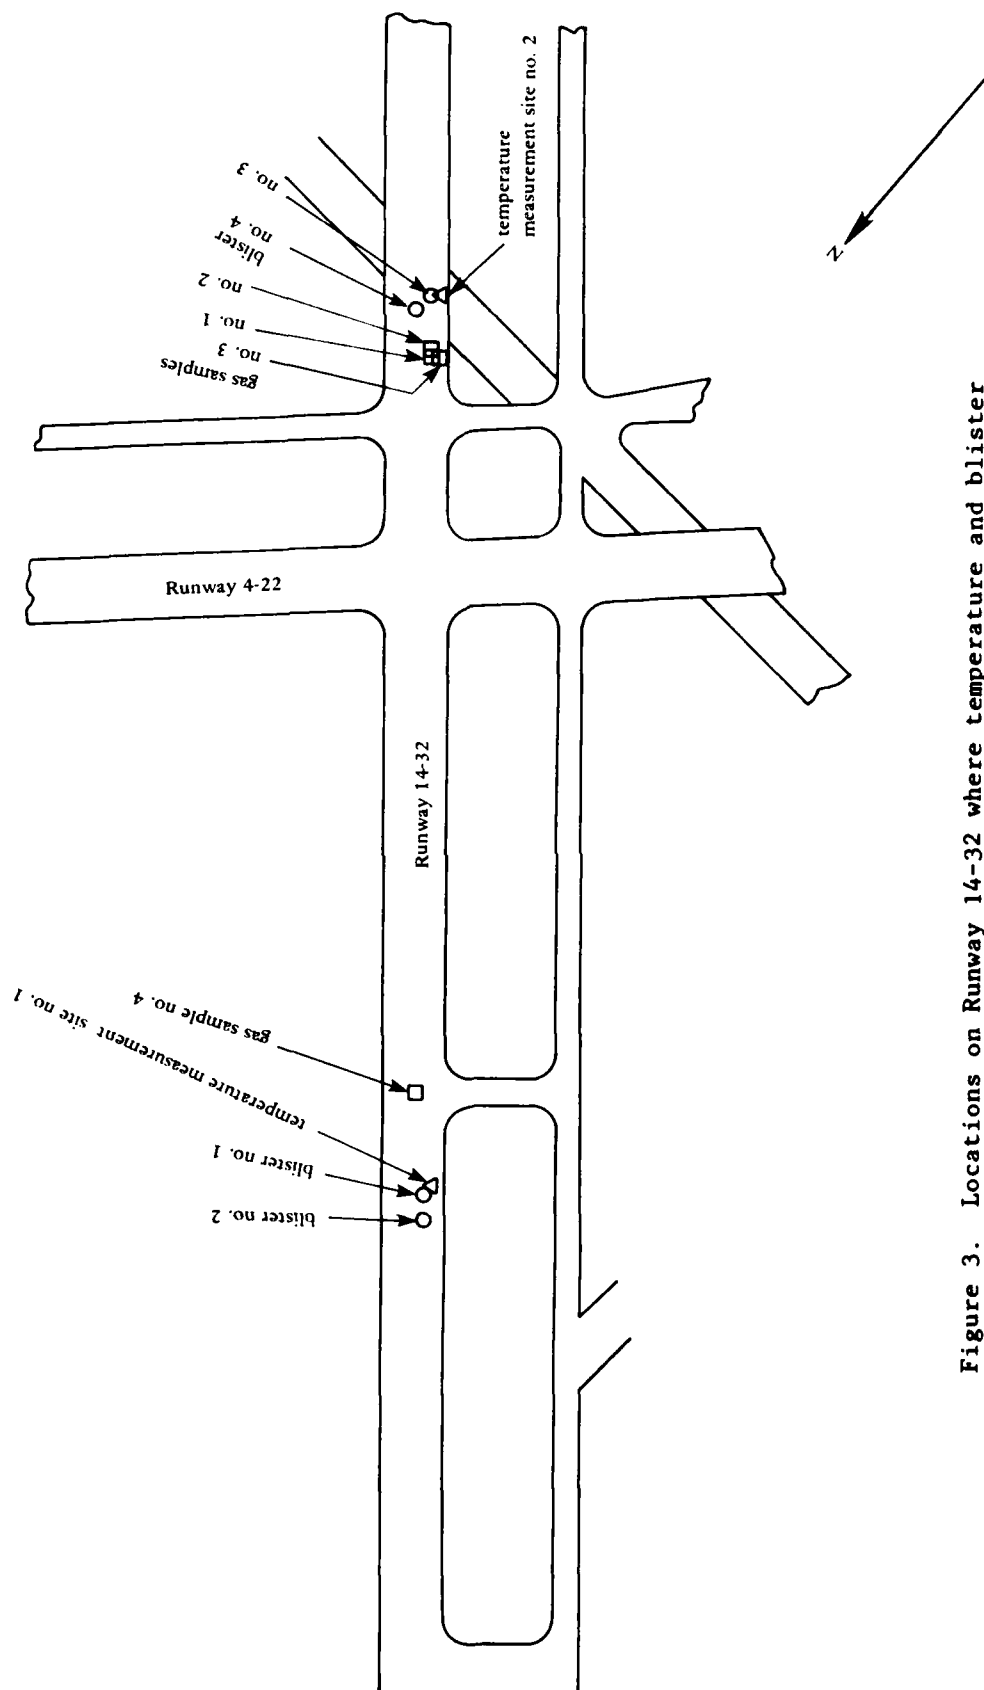
The locations where measurements of pavement temperature profiles and blister elevation changes were made and where samples of the asphalt overlay were taken are shown in Table 2. Locations and ambient conditions for the four blister gas samples are shown in Table 3. The locations on Runway 14-32 where the measurements and samples were taken are shown in Figure 3.

Figure 3. Locations on Runway 14-32 where temperature and blister behavior measurements were made and where gas and AC overlay samples were taken.

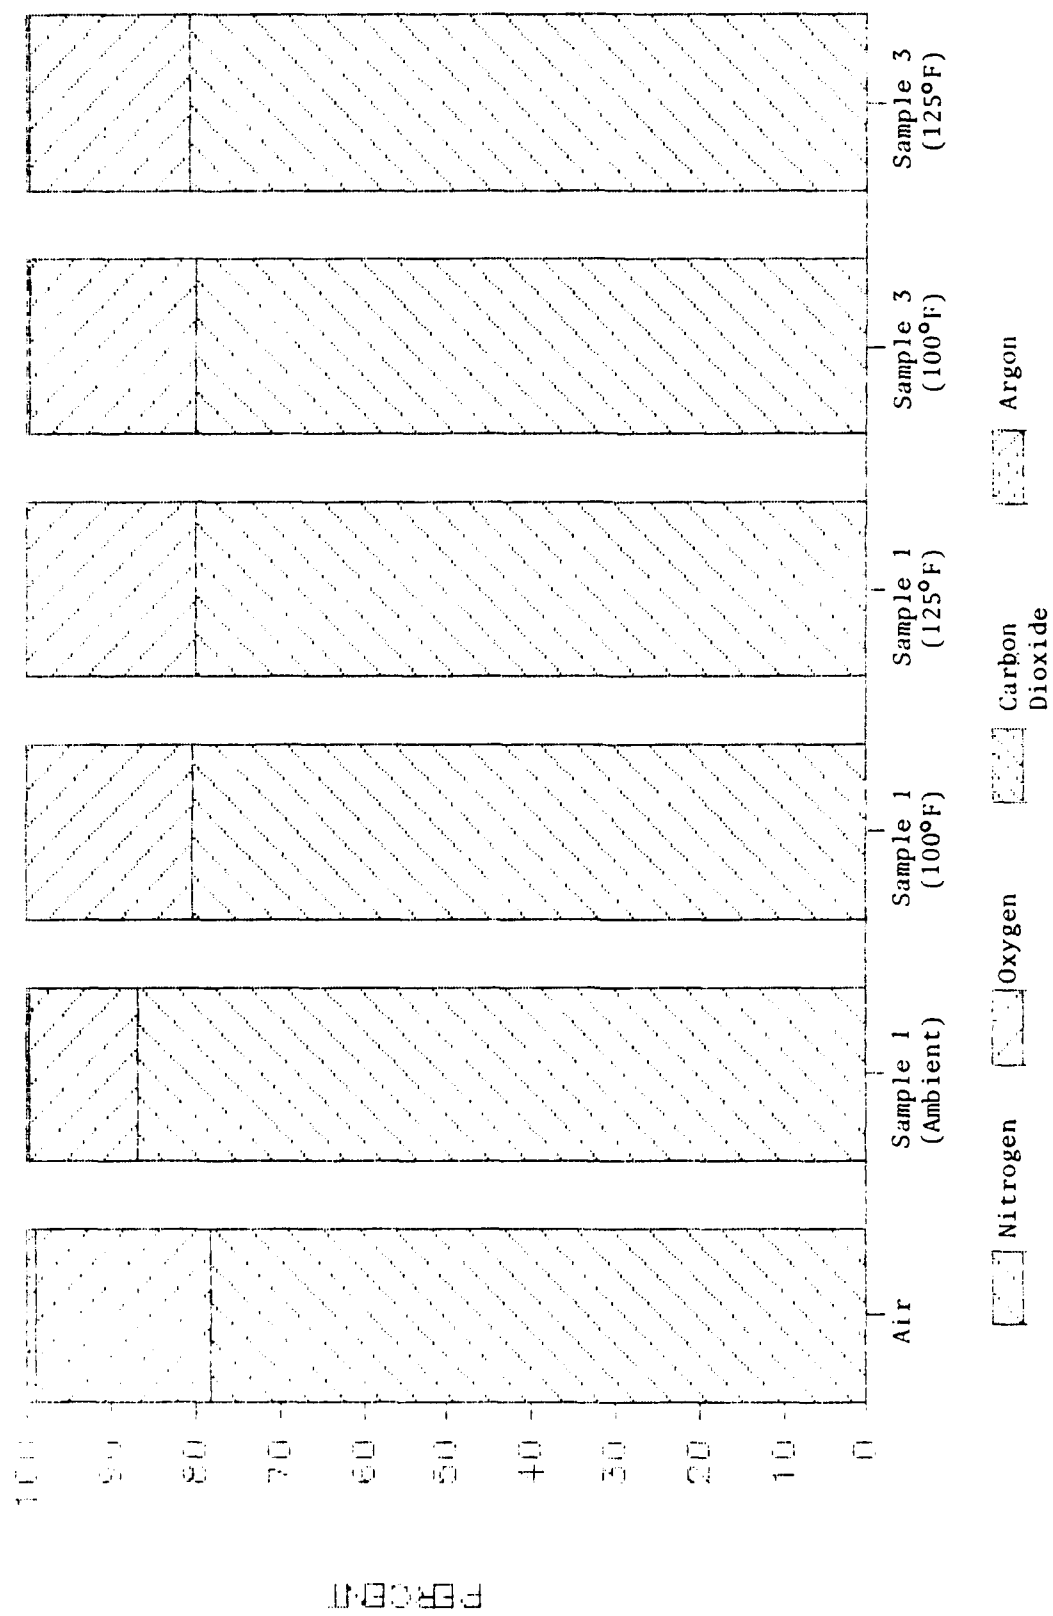
Figure 20. Composition of air compared to measured emitted gas from asphalt pavement samples at various temperature conditions.

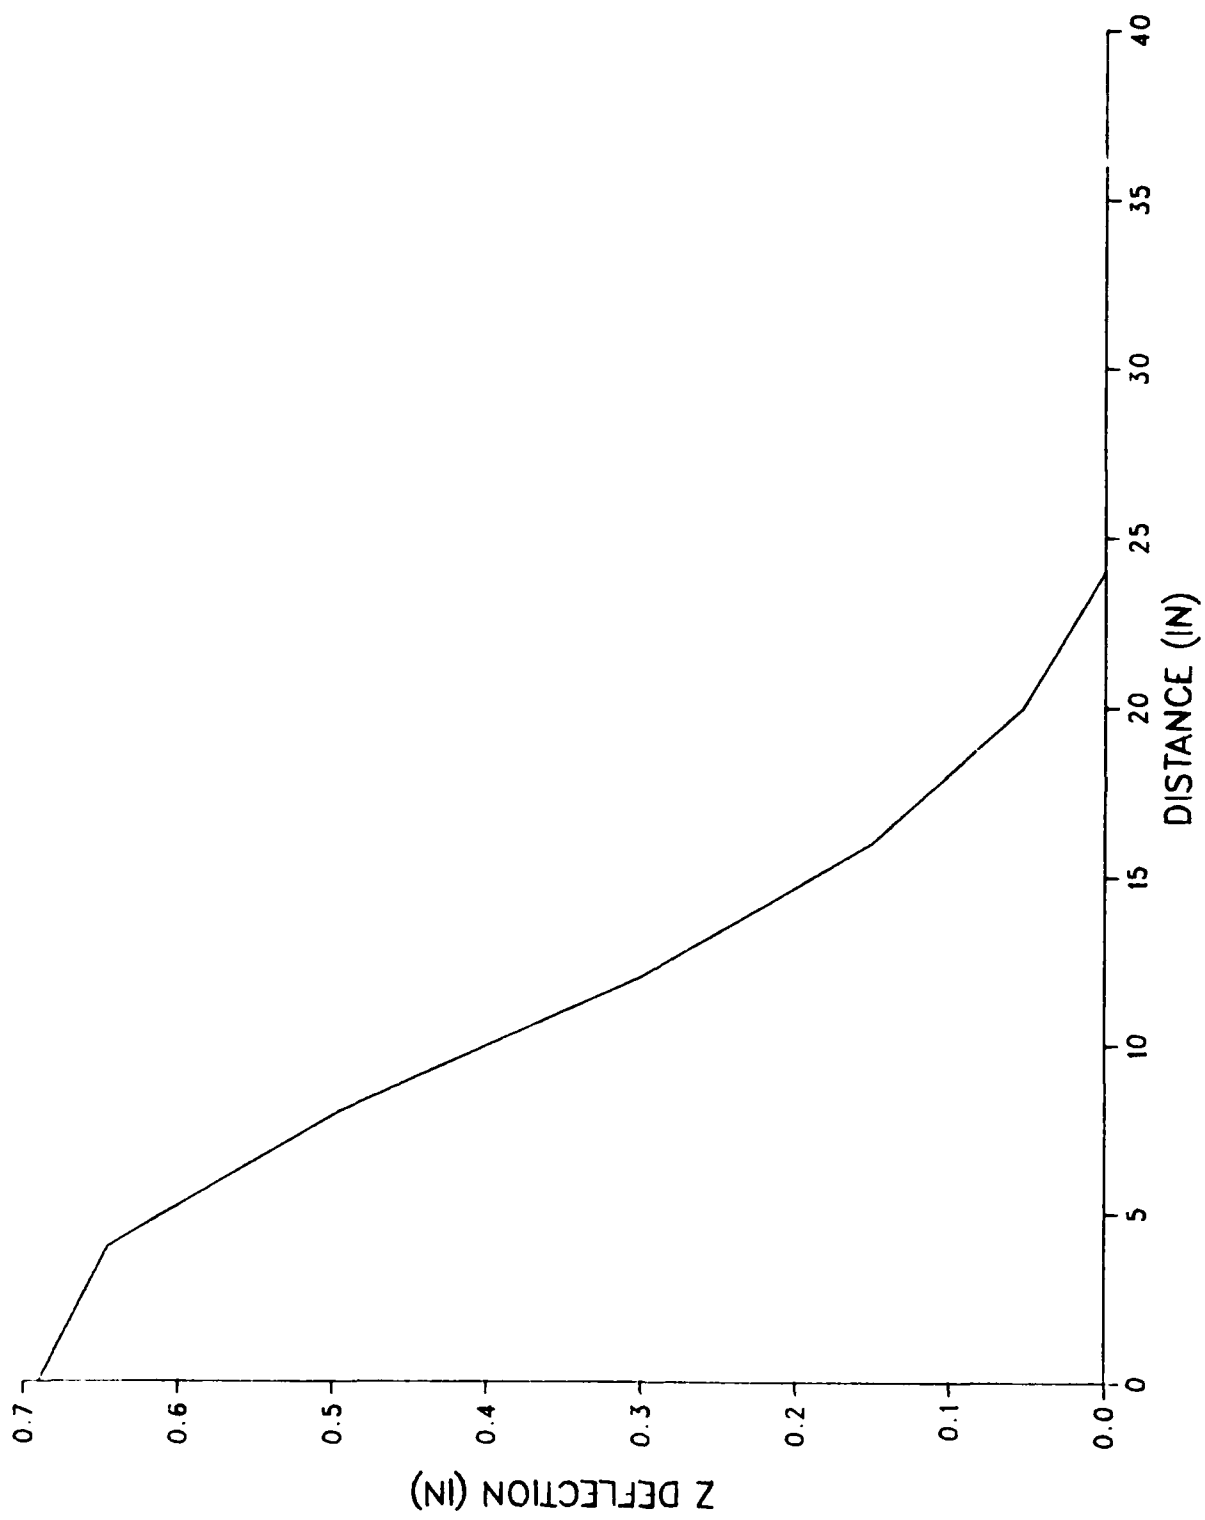
Figure 21. Average half profile of the surface of blister 1.

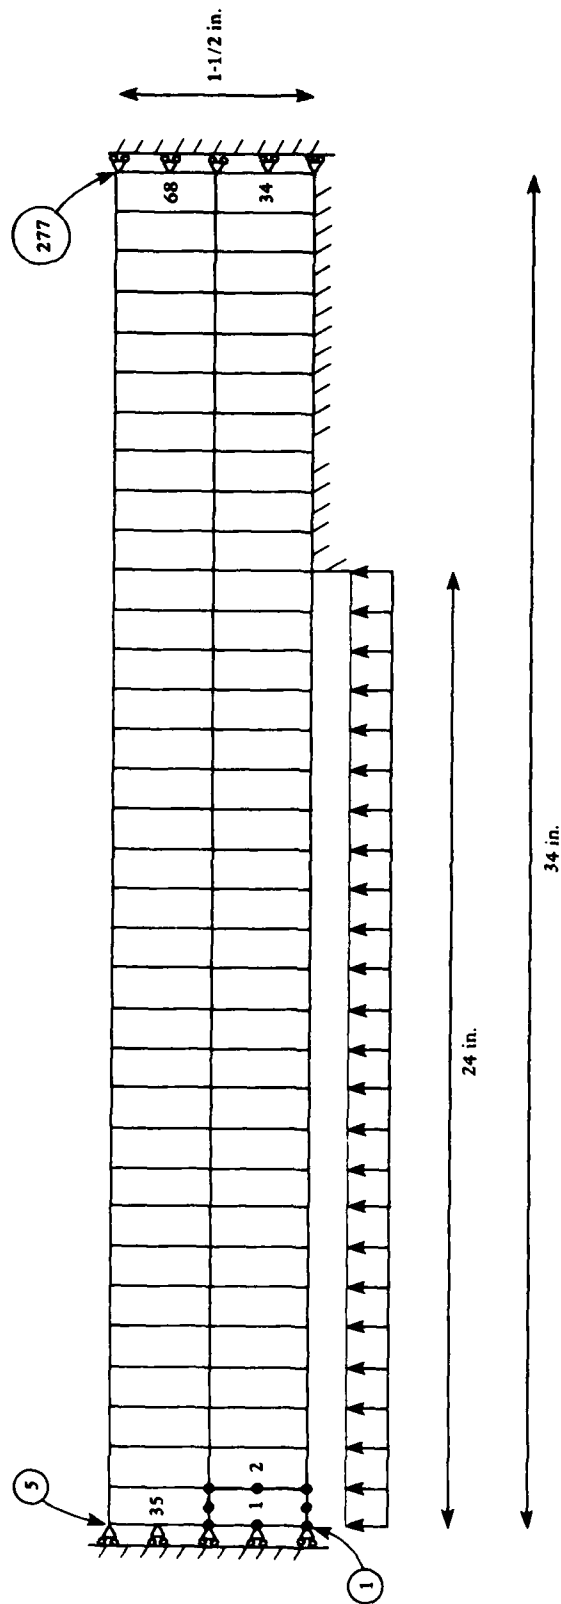
Calculations were made to determine the magnitudes of the internal pressures that are required to raise the blisters at various temperatures. These are pressures that are needed to overcome both the weight, bending stiffness, and membrane tension of the overlay at the respective temperatures. The ADINA finite element program (Ref 4) was used to determine the required internal pressures. The characteristics and behavior of blister 1 was chosen for simulation with the finite element model. Heights along the four radials were averaged (with the vertical expansion of the pavement subtracted out) to determine an approximation of the deformed shape. The profile obtained by averaging the data is shown in Figure 21. The finite element mesh shown in Figure 22 was used to model the symmetric half of a 24-inch radius blister in the 1-1/2-inch overlay.

Figure 22. Finite element mesh used to simulate the characteristics of blister 1.
